Manhole Inspection Summary

Manhole # S31EE2011MH

Insp Date: **11/30/06 12:50 PM**

Location Address: **5700 SAINT ALBANS WAY**

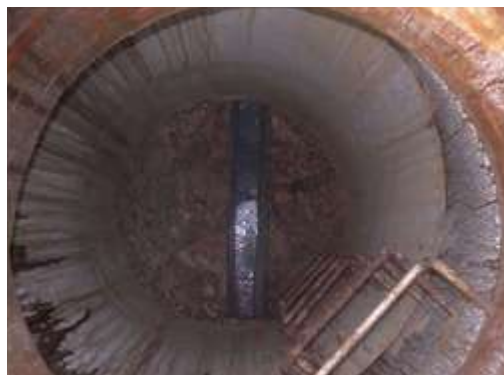
Top View

Bench debris.

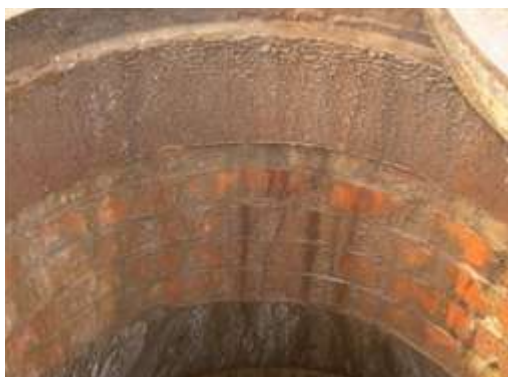
Defect

Frame leaks.

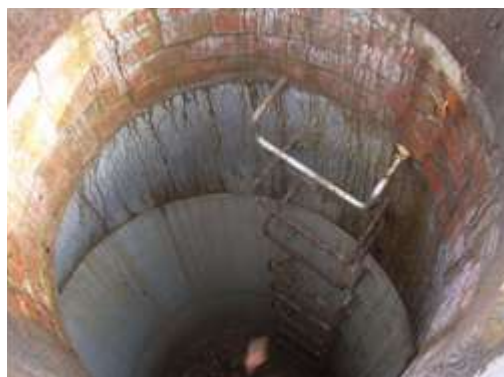
Defect

Frame leaks. Adjustment and Corbel infiltration.

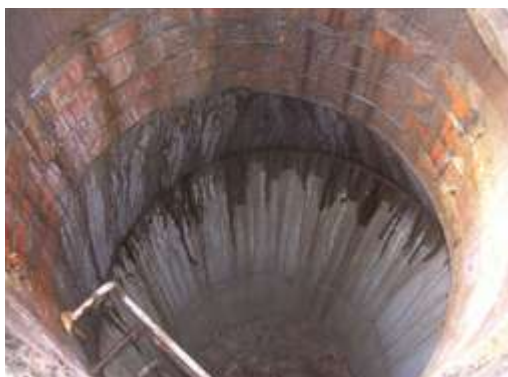
Defect

Frame leaks. Adjustment and Corbel infiltration - other side.

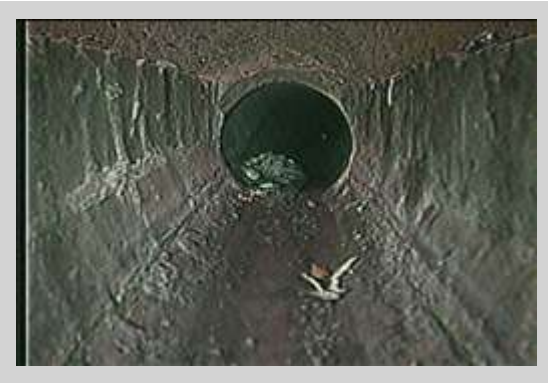
8 in. Circular Gravity Sewer Pipe Out @ 12 O'Clock

Channel deterioration.

Deposits: ☐ None ☐ Mud ☐ Sludge ☒ **Debris** ☐ **Grease**

Infiltration: **Evidence** Pipe Seal Cond: **Unknown**

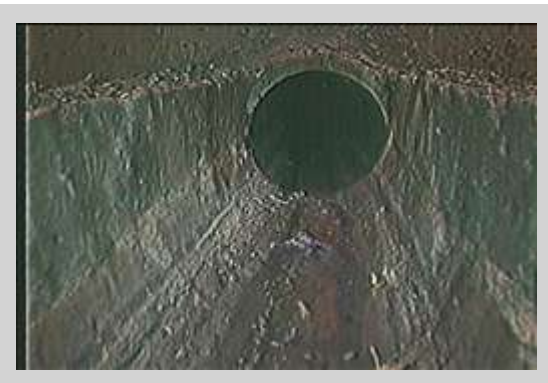
8 in. Circular Gravity Sewer Pipe In @ 6 O'Clock

Deposits: ☐ None ☐ Mud ☐ Sludge ☐ Debris ☒ **Grease**

Infiltration: **Evidence** Pipe Seal Cond: **Unknown**
